Technical Series

00-144

RETROFITTING VENTILATION INTO LOW-RISE HOUSING

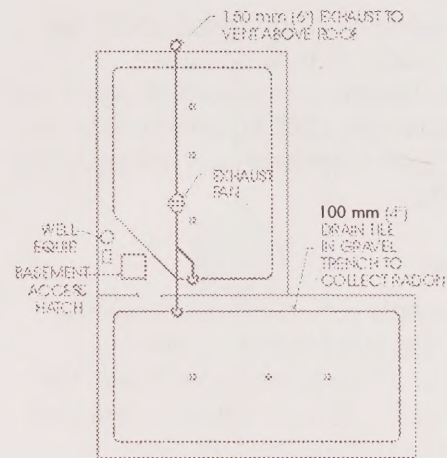
Radon Removal System

The homeowners were concerned with high concentrations of radon gas (a known carcinogen) measured within their house.

Radon gas concentrations were measured using an electronic monitor manually read three times per day, and were reduced from 15.8 pCi/L ("picoCuries per Liter") to 1 pCi/L, a reduction of almost 95%. The current measured level within the house is well under 21.6 pCi/L—the Canadian guideline, and 4 pCi/L—the American guideline for indoor environments. A combination of sub-surface depressurization and sealing the surface of the crawl space significantly reduced radon concentrations while surface sealing alone did not.

The entry of soil gas into crawlspace under house was minimized by sealing major migration locations, including the soil surface, using polyethylene sheeting, and sump lid and crawl space hatch using tight-fitting gaskets. Additionally, soil gasses from under the sealed polyethylene sheeting were collected in a stone-filled trench and perforated piping and exhausted by a fan.

Trenches were dug in the crawlspace following the house perimeter. A 100-mm (4") diameter perforated weeping tile was installed in the bottom of the 300-mm (12") wide x 200-mm (8") deep trench. The weeping tile was encased in pea gravel filling the trench.

The weeping tile was connected to the suction side of an in-line centrifugal fan rated 66 L/s (140 CFM) at an external static pressure of 187 Pa (0.75" W.C.). Soil gasses captured by the perforated weeping tile were exhausted outdoors through a 150-mm (6") diameter duct that extends above the eaves.

The surface of the soil was covered with 6-mil polyethylene sheeting. All the joints in the sheeting were sealed with an acoustical sealant and the edges of the sheeting were sealed to the foundation walls. The sump-pit lid and access hatch cover were sealed using airtight gaskets.

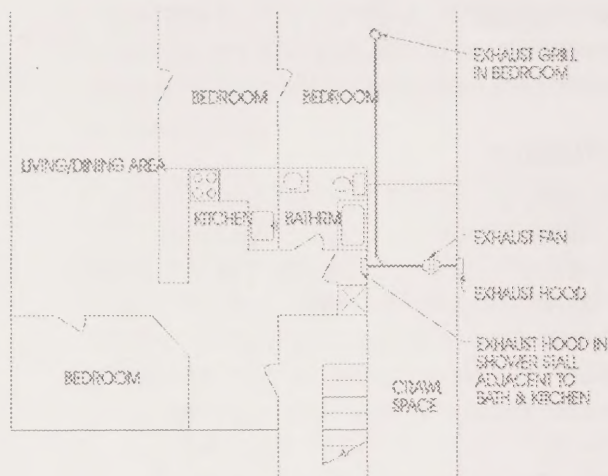
Exhaust Layout

The homeowner was concerned about the indoor air quality in their basement apartment. Tenants complained of odour and moisture build-up. Cooking odours from the basement apartment were also noticeable on the main floor.

The ventilation retrofit reduced overnight build-up of CO₂ by approximately 45%. The tenants confirmed that the air in the basement apartment seemed fresher and less humid. There have been less odours coming from the apartment since the retrofit.

An exhaust-only ventilation system was installed with multiple pick-up points dedicated to the basement apartment. The system exhausts air from the basement and draws air down from the main floor, changing natural ventilation flows in the house. The system introduces ventilation into the basement while simultaneously reducing exfiltration through upper parts of the house. The new ventilation rate is less than the sum of the original infiltration rate and mechanical ventilation added.

A 100 L/s (210 CFM) exhaust fan was installed in a crawlspace adjacent to the basement apartment. Two exhaust grilles were installed—the first in a shower stall and the second in a bedroom. To minimize operating costs, the exhaust fan operates on an event timer based on the occupant's weekday (on at 4:00 p.m.; off at 8:00 a.m.) and weekend (24 hrs/day) schedule.

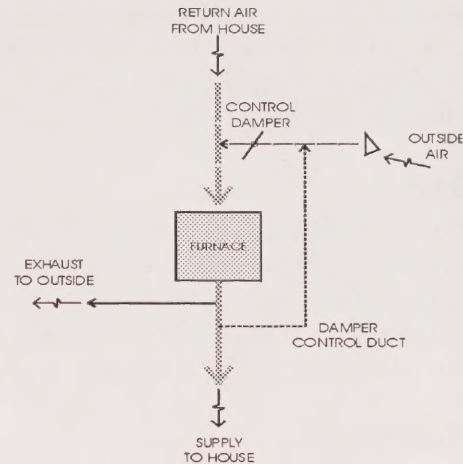
Fresh Air Control System

Occupants were concerned that health symptoms were caused by insufficient ventilation resulting in poor indoor air quality.

CO₂ tracer gas measurements show that even a leaky house has virtually no ventilation on mild, calm days, that mechanical ventilation can introduce adequate levels of ventilation, and combining mechanical and natural ventilation can produce higher air exchange rates than either alone.

An outside air duct was connected to the furnace return to provide outdoor air to the house. The "Fresh Air Control System" (Wait Model 970) is a heat-activated damper that opens the intake duct only when the furnace is operating. An exhaust duct to outside from the furnace supply duct was installed without a damper.

A 150-mm (6") diameter insulated duct is connected from an outdoor hood to the furnace return. A 100-mm (4") diameter uninsulated duct is connected from the supply air duct to the outdoors. The furnace fan operates continuously at low speed, cycling to high speed on a call for heating or cooling. The "Fresh Air Control Damper" is installed in the fresh air intake duct just upstream of the furnace return. When the damper is not activated, it is held open at a minimum setting to allow some fresh air to be drawn in.

A 75-mm (3") diameter bypass duct runs from the furnace supply air duct to the "Fresh Air Control Damper". Air continuously circulates through this bypass duct passing over a bimetal operator in the damper. During a heating cycle, the heated bypass air causes the bimetal operator to open the damper blade so a larger volume of make-up air is then drawn into the furnace.

The 100-mm (4") diameter exhaust provides relief of over-pressure in the house caused by the intake duct. It is recognized that during certain points of operation, some heated house air is exhausted.

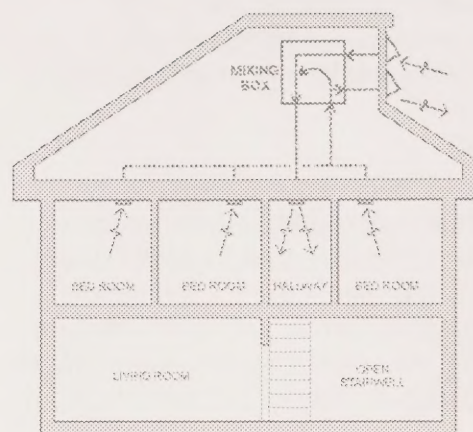
Mixing Box Installation

The homeowners identified indoor air quality as a concern based on excessive condensation on the windows and mold growth in the second floor bedrooms.

A CO₂ concentration reduction of almost 50% was found after the mixing box was switched on. Bedroom temperatures were reduced slightly during this relatively mild period. Calculations show that the tempered air at -20°C outdoor conditions could be delivered at under 10°C possibly causing cold drafts. Consideration should be given to issues such as equipment serviceability and potential duct leakage for any equipment that may be installed in an attic.

A “Mixing Box” ventilator (Nutech VentMax air exchanging ventilator) with ventilate/recirculate functions was mounted in the attic. A humidity control is used to activate the “ventilation” function on demand.

Air is drawn from the three bedrooms on the upper floor and supplied to the upper floor hallway when in recirculate mode. If the humidity rises above the set-point of the hallway-mounted controller, the ventilator switches from low to high airflow and opens the outdoor damper. Outdoor air is blended with the air being recirculated from the bedrooms. A portion of the blended air is exhausted outside to balance the ventilation flow. When humidity falls below the set-point, the unit returns to low speed, and closes the outdoor air damper.

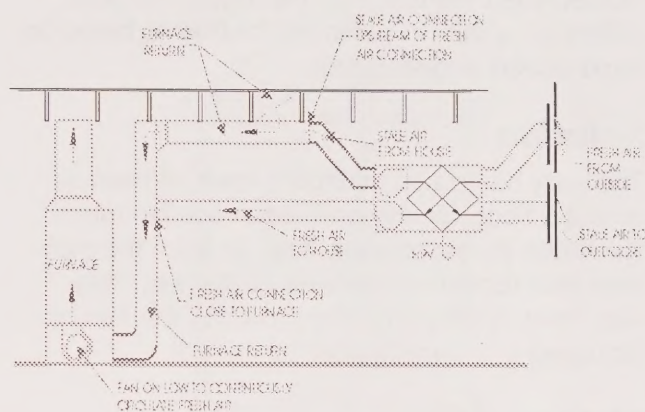
HRV Retrofit

The homeowners had concerns about poor indoor air quality based on a perceived air staleness and excessive humidity.

Quantitative results show an average 15 L/s increase in ventilation air supplied to the house and a 14% decrease in CO₂ concentrations. Quantitatively, the homeowners found that humidity levels in the house were reduced as condensation was practically eliminated from windows and the bedrooms felt fresher. This suggests that the increased ventilation resulted in an overall increase in indoor air quality. Ventilation air was effectively distributed throughout the house and the homeowner now has the ability to automatically or manually increase ventilation based on the humidity or other comfort factors. Heat recovery reduces annual operating costs while the continuous operation of the fan (which previously operated intermittently) increases them. An HRV is a relatively expensive piece of equipment but in the long run, heat recovery does have a payback.

An HRV was retrofitted to provide balanced mechanical ventilation with heat recovery. The furnace fan and supply ducting was used to effectively distribute fresh air to every room in the house.

A standard HRV was installed in the basement with outdoor supply and exhaust hoods installed through the rim joist. Fresh supply air and stale exhaust air are both connected to the existing furnace return duct with the exhaust connection being upstream of the supply to eliminate short circuiting. Distribution of fresh ventilation air occurs via the furnace supply ducting using the furnace fan on low speed continuously. The HRV is operated on low speed for 20 minutes per hour and is turned off for 40 minutes. A dehumidistat turns the HRV on high speed when humidity levels rise.

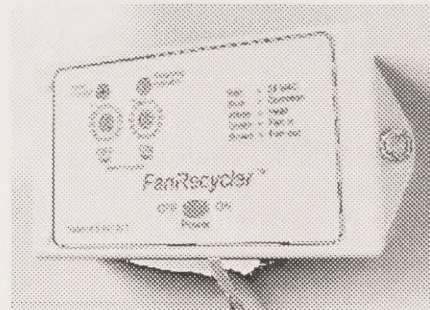
Furnace Fan Cycling Control

Homeowners are concerned with possible poor indoor air quality in basement bedrooms based on mold odours and stuffiness.

Efficacy was quite good with overnight build-up of CO₂ concentrations reduced by 25%. The homeowners believe that other airborne contaminants such as humidity and odours have also been reduced significantly. Basement contaminant levels are reduced as air throughout the house is mixed. Contaminants are then carried out of the house with air exfiltrating from the main floor.

The leaky house had abundant levels of fresh air on main floor. Turning on the furnace fan mixed the house air, introducing fresh air from the main floor into the poorly ventilated basement. This was done by intermittently activating the furnace fan using a furnace fan cycling control.

A commercially available special-purpose controller is retrofit to the furnace. The controller operates the furnace fan intermittently. The house air is mixed and turned over. Fresh air from the main floor is introduced to the basement. To avoid excessive fan operation, the controller turns the fan on only if the thermostat has not activated heating or cooling during the previous OFF period.

Fan on and off times are independently adjustable. The initial setting chosen was 10 minutes ON and 50 minutes OFF.

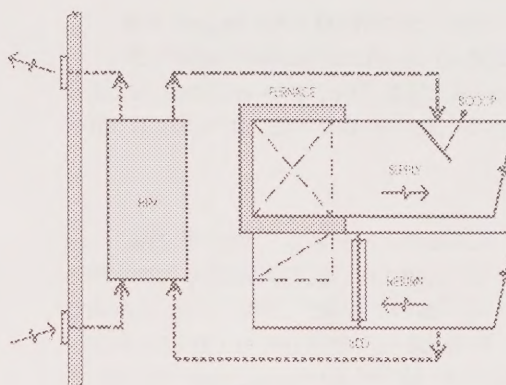
Modified HRV Retrofit Installation

Homeowners identified indoor air quality concerns based on stuffiness in bedrooms, condensation on windows and in exhaust ducts, and mold growth on the bathroom ceiling.

Carbon dioxide levels in the master bedroom were reduced from nighttime peaks of approximately 1,000 ppm to 500 ppm. Relative humidity in the space was reduced from nighttime peaks of approximately 45% to 35%. The occupants also reported a noticeable improvement in the freshness of the air in the house.

Install an HRV to provide balanced mechanical ventilation. This ventilation unit exhausts stale, moist air, and supplies fresh, dry air to the house. Heat recovery is used to minimize the costs of providing ventilation.

A residential HRV was installed in the basement near the furnace. Exhaust air was drawn from the existing furnace return to draw stale air from various parts of the house. To provide effective distribution of fresh air, the HRV supply duct was connected to the furnace supply duct. An adjustable damper was installed in the furnace supply duct over the opening for the HRV connection creating a venturi to keep the HRV flow from being affected by furnace fan operation. A backdraft damper was installed in the furnace return duct downstream of the HRV exhaust to prevent fresh air from short-circuiting through the furnace to the HRV exhaust when the furnace fan is off. Using only the HRV fan to distribute fresh air reduced operating costs.
